PN 83042-1: Mandatory Condensate “Y” Upgrade

Upgrade Reason:

Models Covered: **SERIAL NO. T06-16000 or greater ONLY**

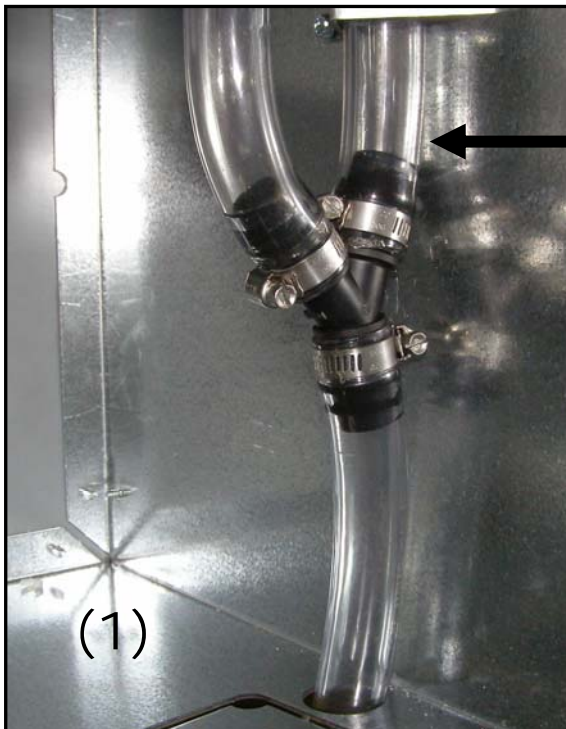
- 1) Identify the color of the Condensate Y; if it is black replace it.

CAUTION: Do not cut or pull on this tube. It must remain connected to the boiler.

If the tube is disconnected from the back of the boiler, the boiler will need to be removed to repair.

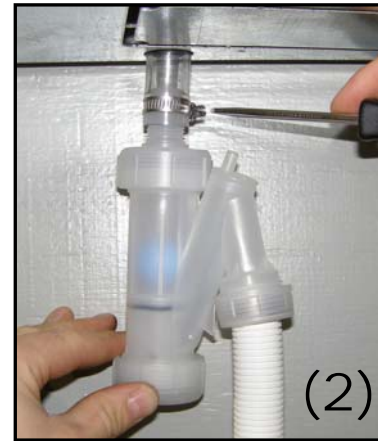
- 2) Turn power off and remove the condensate trap from underneath the boiler.

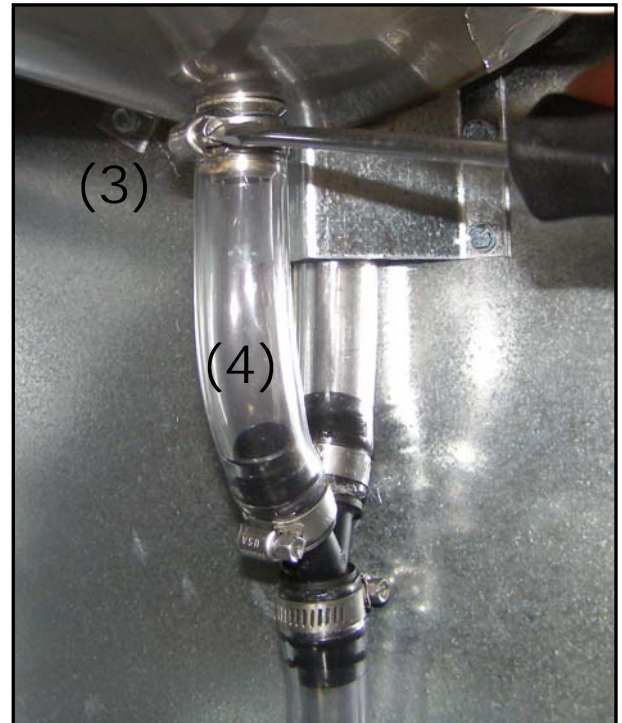
- 3) Working inside the boiler cabinet remove the clamp securing the front condensate drain hose to the Heat Exchanger.

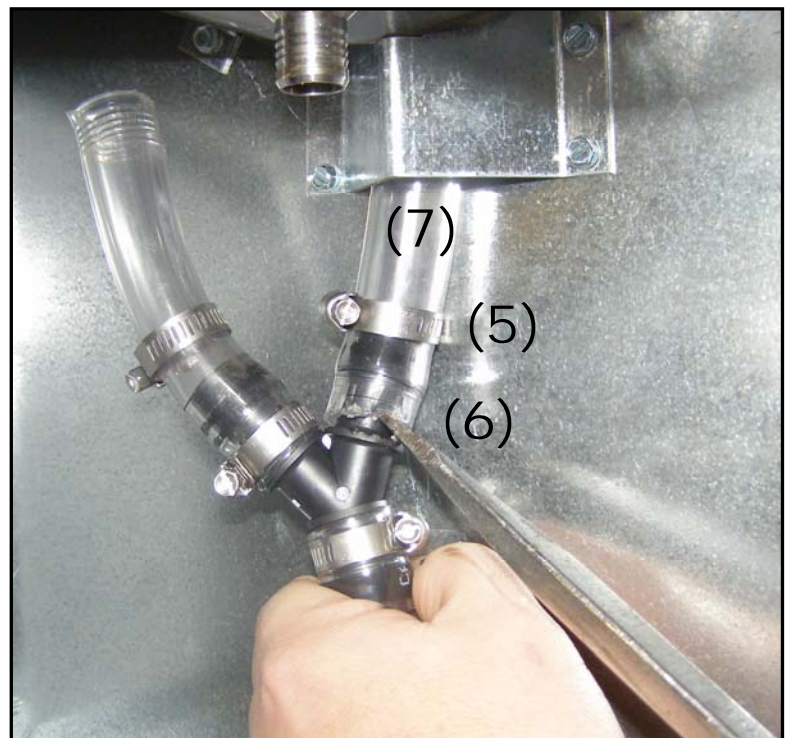
- 4) Disconnect the hose from the boiler only.

- 5) Loosen the clamp, and move it out of the way.

- 6) Very carefully, using a wide tipped flat screwdriver pry the tube off the "Y" connector.

- 7) **DO NOT PULL THE TUBING DOWN, AS IT MIGHT DISCONNECT FROM THE BACK.**

- 8) Remove the assembly and disconnect the remaining tubes from the old Y then re-install and secure the tubes onto the new Y (*Install longer tube on the bottom Y fitting*).
- 9) Install the new Y and connect the trap to the condensate drain.
