NTI - Mandatory Service and Inspection Program

(For T-Series boilers only)

Overview

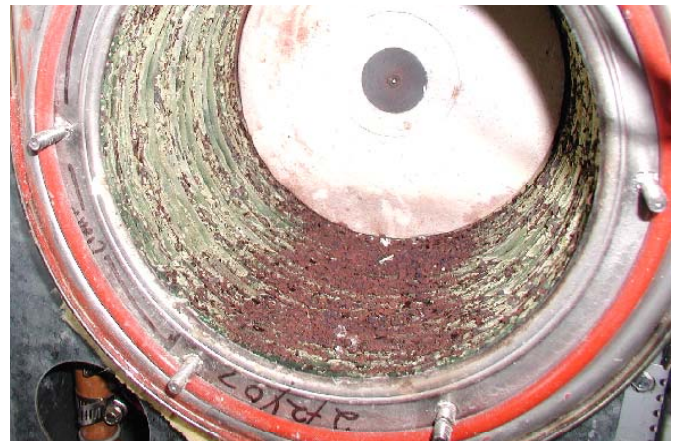
The rate of build-up will vary in every application due to variations in the above-mentioned factors. However, it is important that the boiler primary heat exchanger (combustion chamber) be checked for build-up at-least once every two heating seasons or sooner if the boiler has been converted to operate with LP Gas. Once you have established the rate of build up for each installation, you will be able to develop a cleaning schedule.

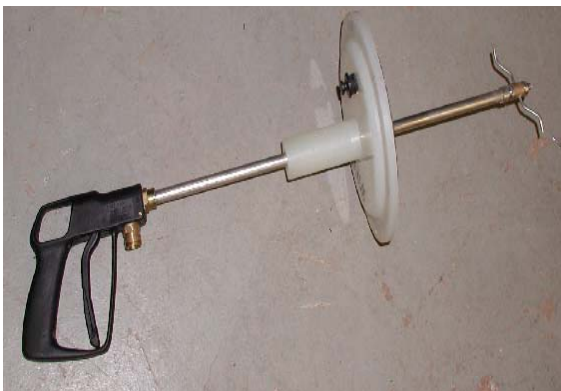
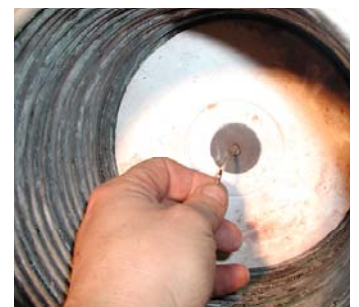
- 8) Vacuum out the loose combusted dust deposits and debris from the heat exchanger. Use a nylon or other nonmetallic brush to loosen surface deposits. Vacuum out again if necessary.

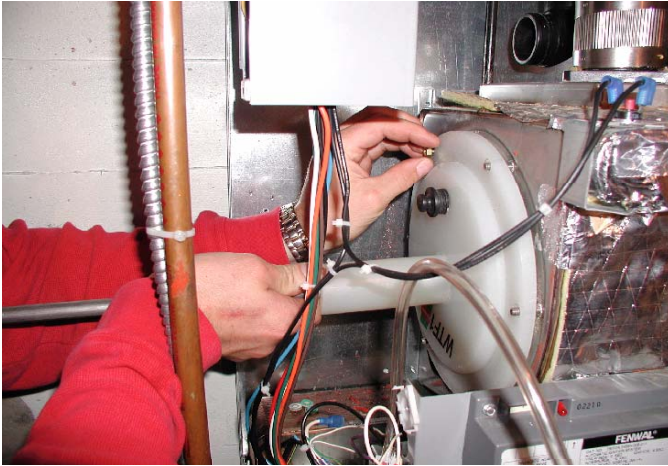
- 9) If you have an NTI cleaning wand Pn. 82721 you may install the wand onto the boiler where the burner door was located.
- 10) Remove the condensate trap and allow the tube to drain straight into a bucket.

- 11) Connect wand to pressure washer, and begin to wash. Push wand in and out repetitively while washing. Continue until the water exiting the condensate drain is clear. Wash for at least 5 minutes, oscillating trigger frequently. If not clean after door is removed, brush again to removed caked on material and repeat the process.

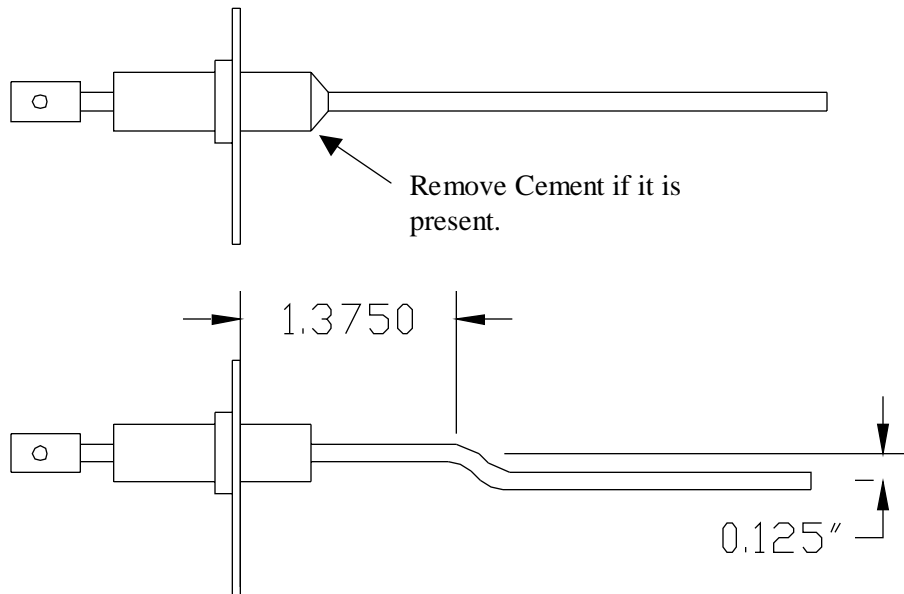
1. Check, and if necessary, adjust combustion to the proper level as per the above.
2. Check flame signal strength at maximum and minimum firing rates. If the signal is lower than $2.0\mu\text{A}$ at either rate, change the position of the flame probe relative to the flame by removing the flame probe and bending as shown in the figure. When bending of the flame probe is required, start by bending it $1/8$ " further away from the flame, see diagram.

4. Under many operating conditions the combustion chamber will become humid. To reduce the likelihood of the flame probe "shorting" to ground, remove the cement from the base of the flame probe, if it exists, and ensure the flame probe hole is free of debris, which will contribute to the likelihood of a "short".
