NY Thermal Inc.
Tel: (506) 657-6000
Toll Free: 1-800-688-2575
Fax: 1-506-432-1135
Web: www.nythermal.com
Email: info@nythermal.com

**85022 / 85023 / 85024 / 85025 / 85026/ 85760/ 87504/ 87505/
87506/87507/87508**

**Tx151-200 Heat Exchanger Assembly, ASME
Post Serial # 72000
c/w Burner Door and Flue Box**

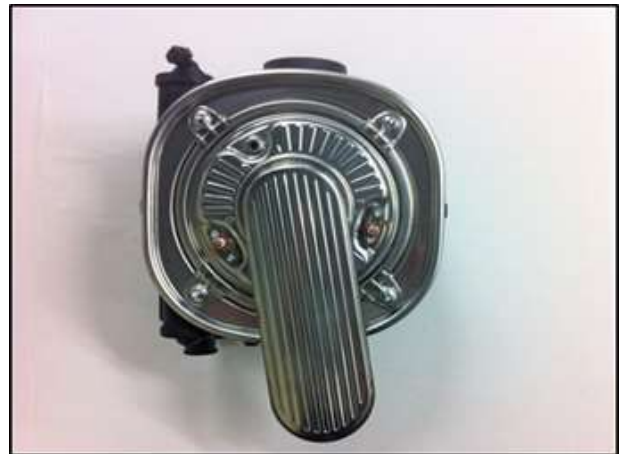
- 85022/87508 Heat Exchanger Assembly Tx51 **OR**
 - 85023/87507 Heat Exchanger Assembly Tx81 **OR**
 - 85024/85760/87506 Heat Exchanger Assembly Tx101 **OR**
 - 85025/85761/87505 Heat Exchanger Assembly Tx151, Tx151C **OR**
 - 85026/87504 Heat exchanger Assembly Tx200, Tx200C
- Installation Instructions
